Rad <sup>1</sup>	<b>Analysis of Causes of Degradation of Parent Material and Weld Metal of Breeches Pipe nr. 1 of Pipeline III at Hydroelectric Power Plant "Perućica"</b>
ISSN časopisa	<b>1451-3749</b> <b>EISSN 1820-7863</b>
Impakt faktor časopisa <sup>2</sup>	<b>0,21 (SCOPUS)</b>
Datum objavljivanja rada	<b>2015</b>
Naziv liste kojoj časopis pripada	<b>Emerging Sources Citation Index (ESCI)</b> <b>SCOPUS</b>
Ukupan broj autora	<b>5</b>
Broj autora koji nisu zaposleni na UCG	<b>4</b>
Naziv vodećeg autora	<b>Simon Sedmak</b>

## ANALYSIS OF CAUSES OF DEGRADATION OF PARENT MATERIAL AND WELD METAL OF BREECHES PIPE AT HYDRO POWER PLANT 'PERUĆICA'

Originalni naučni rad / Original scientific paper

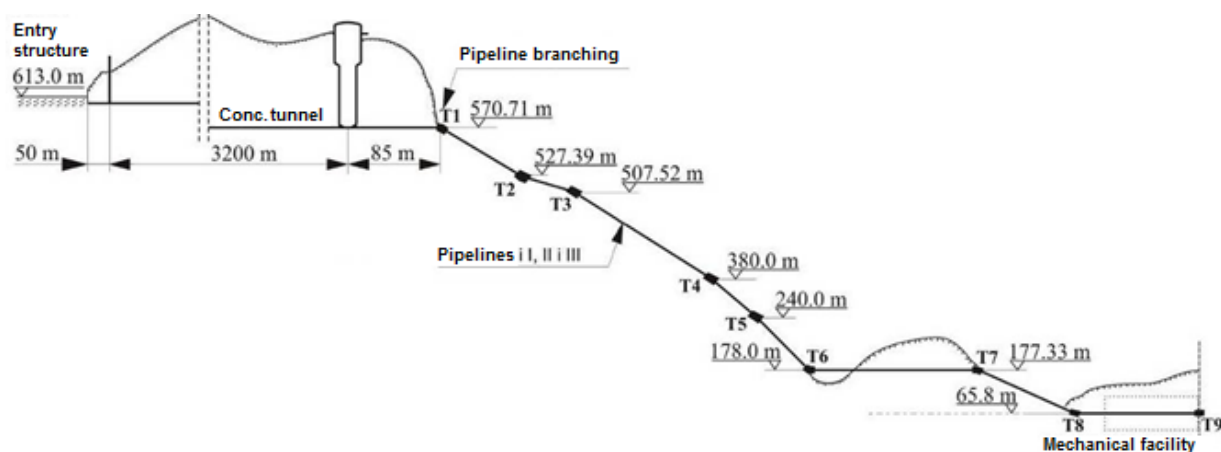
Figure 1. Schematic appearance of hydroelectric power plant 'Perućica'.

Hydroelectric power plant 'Perućica', which comprises 7 hydroelectric generating sets with an installed power of 330 MW, is the oldest large hydroelectric power plant in Montenegro. It was put into service in 1960. From the accumulations 'Krupac', 'Slano' and 'Vrtac' the water is being brought to the hydroelectric generating set by three pipelines under pressure of 61 bar, /1/. Pipeline I, 1851 m long with diameters 1.8-2.2 m supplies two hydroelectric generating sets (A1 and A2) with nominal power of 38 MW each. Pipeline II, 1883 m long with diameters 2.1-2.2 m supplies three hydroelectric generating sets (A3, A4 and A5) with nominal power of 38 MW each, while pipeline III, 1931 m long with diameters 2.5-2.65 m supplies two hydroelectric generating sets (A6 and A7) with nominal power of 58.5 MW each, Fig. 2. In Fig. 3 the appearance of the Pelton turbine is shown.

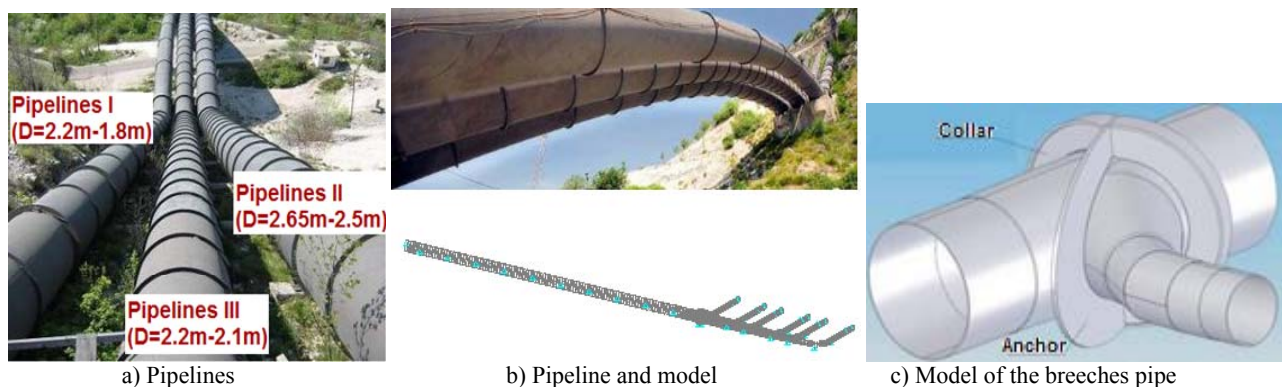
Figure 2. Intake pipelines with suitable models of pipe and breeches pipe.

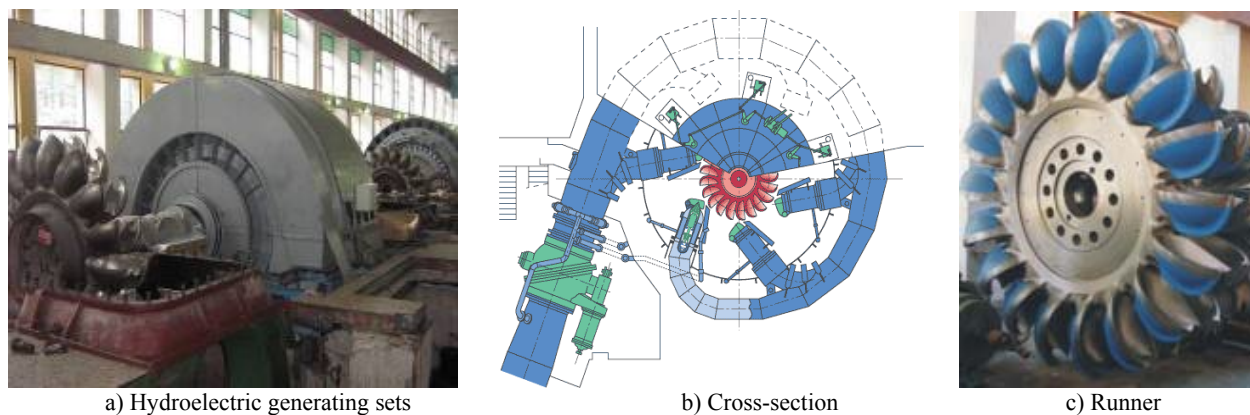
Figure 3. Appearance of a Pelton turbine.

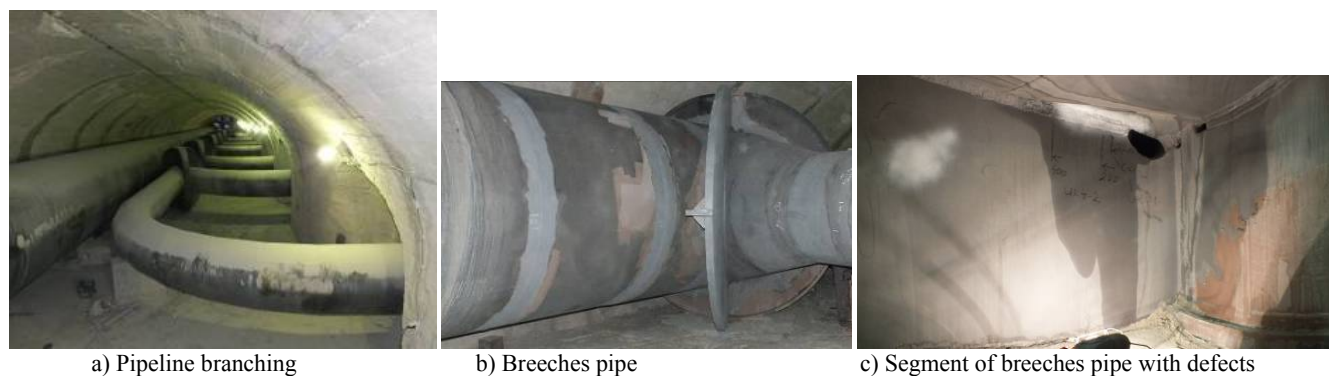
Figure 4. Pipeline III with defects in parent material and welded joints.

in that area, which occur during the process of performing in-service functional tasks (stationary and dynamic loads) and during the disturbed process of exploitation (non-stationary dynamic loads), led to the increase of the level of damaging of the parent material and welded joints at the structural parts of the breeches pipe (collars and anchors), which endangers the integrity of the pipeline structure as a whole, Fig. 4. The role of the collar, over which the breeches pipe leans on the foundation, is to receive static and dynamic loads (mean pressure in the pipeline of 61 bar, specific load caused by the quantity of water in the pipeline, effect of gravitational force) and displacements that occur due to non-stationary dynamic loads, while the anchor has the role in strengthening and balancing the mass of the breeches pipe. Significant propagation of the defect at the carrying structure of breeches pipe no.1, mostly at parent material of the anchor and welded joint, between the collar and the anchor, as well as between the pipeline and the anchor, has led to the fact that in 2012 the breeches pipe started to lean not on the collar, but on the anchor, Fig. 5b.

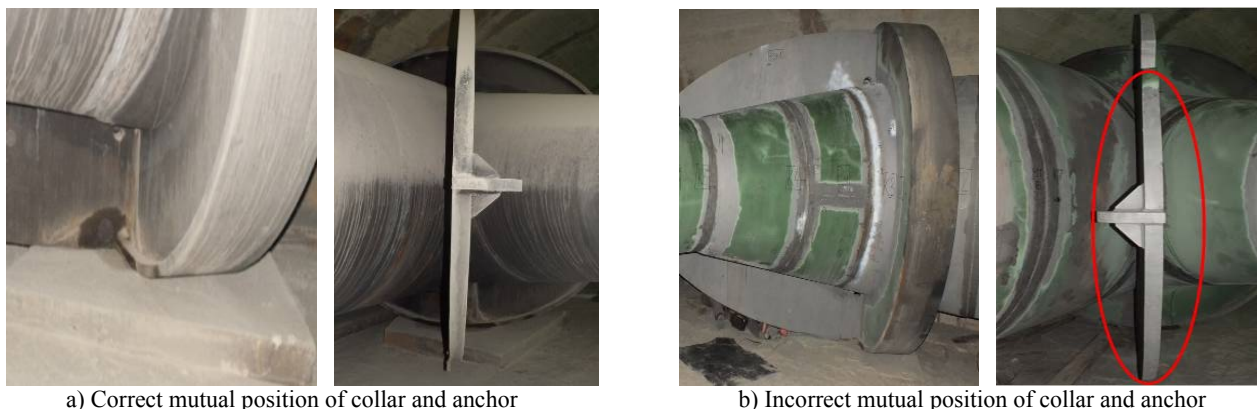
a) Correct mutual position of collar and anchor  
b) Incorrect mutual position of collar and anchor  
Figure 5. Correct mutual position of collar and anchor at breeches pipe and the damage at the anchor caused by bending initiated by incorrect mutual position of collar and anchor (bending of the anchor is shown in Fig. 5b).

Test results show that the major cause for damage occurrence in the load carrying structure of breeches pipe no.1 of pipeline III at hydroelectric power plant 'Perućica', or in other words of the parent material degradation in the anchor and welded joints placed between the collar and the anchor, and between the pipeline and anchor, is that the breeches pipe started to lean not on the collar, as defined by the project, but on the anchor which could not endure all loads that occur during service.

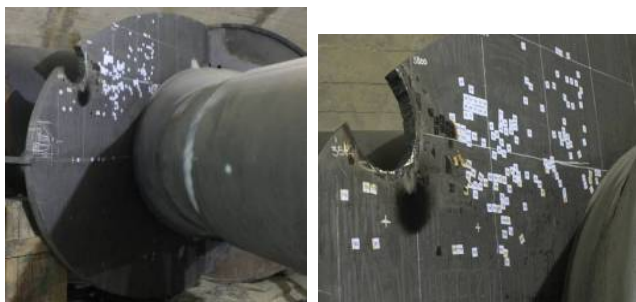
Locations of samples needed for determination of chemical composition, tensile properties, impact energy and hardness are shown in Fig. 6.

Figure 6. Locations of samples for destructive tests.

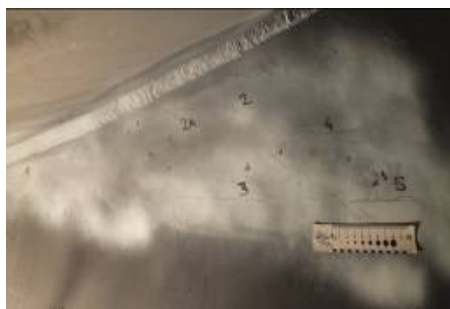
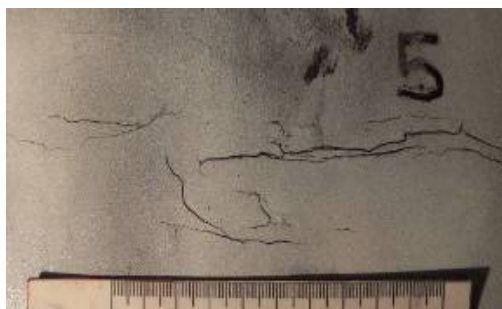
Figure 7. Cracks at the surface of parent material of the anchor of breeches pipe no.1.

Examples of defects detected at parent material (PT), heat-affected zone (HAZ) and weld metal (WM) of the breeches pipe no.1 through visual (VT), /2/, and magnetic particle testing (MT), /3/, are shown in Figs. 7-9. It is determined through ultrasonic testing (UT), /4/, that cracks in parent material presented in Figs. 7 and 8 are 13-32 mm deep, while cracks in the weld metal are 25-52 mm deep.

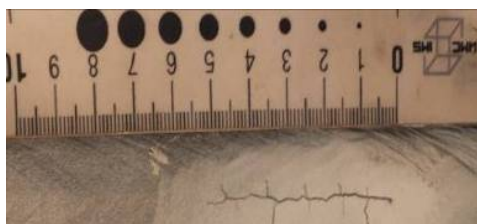
a) Cracks at the surface of WM

Figure 8. Appearance of cracks detected at parent material and welded joints of breeches pipe no.1.

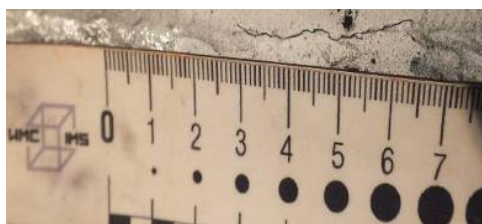
b) Cracks in the HAZ

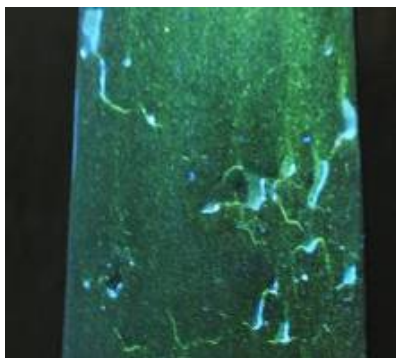
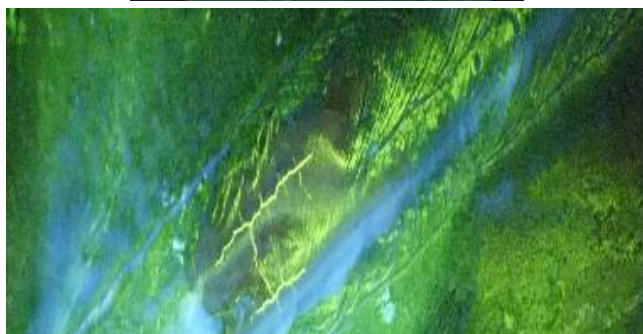
Figure 9. Defects detected in parent material and welded joints of anchor of breeches pipe no.1.
